Certification Tests on Cold Patch Asphalt Repair Materials for Use in Airfield Pavements

June 2010

Final report

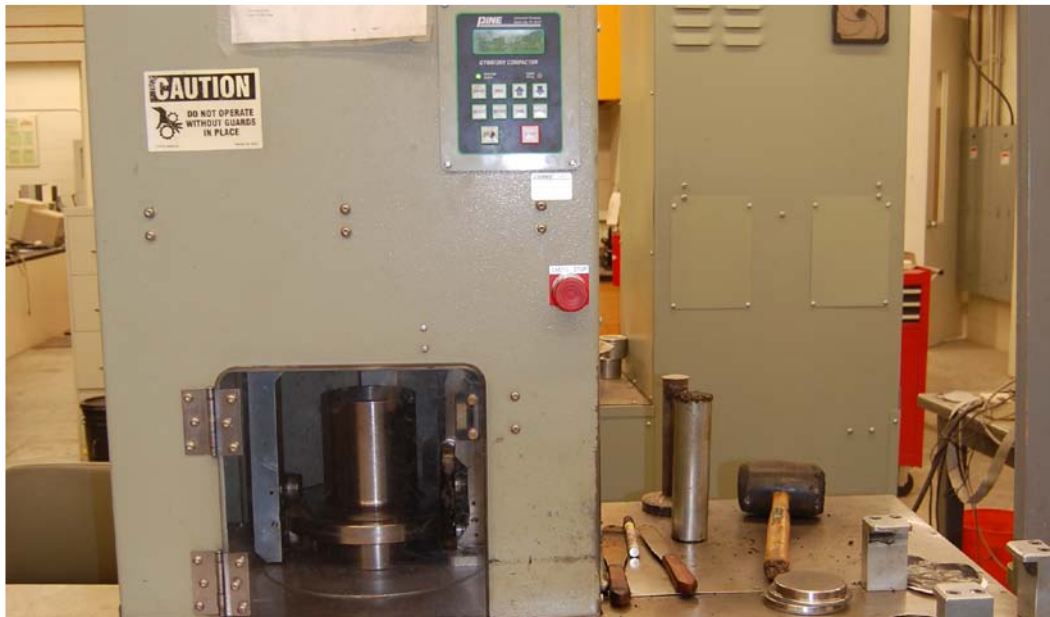
Figure 1. Gyrotory compactor.

Flow time (FT) and flow number (FN) tests were conducted under confined test conditions using four replicate test specimens for each product. All test specimens were compacted using the gyratory compactor and a 3.4-in.-diam mold.

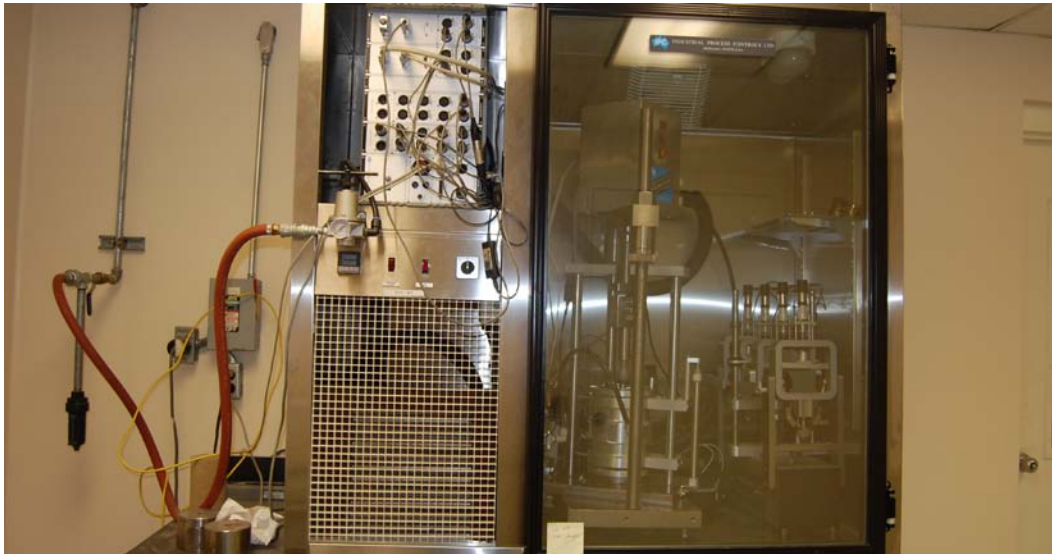
Figure 2. IPC universal testing machine (UTM 25) and temperature chamber used for static and dynamic creep tests.

An IPC universal testing machine (UTM 25) electropneumatic system (Figure 2) was used to test the specimens. The machine has the capacity to apply a confining pressure of up to 90 psi and a maximum vertical load of up to 5,500 lb. The load was measured with a load cell, and the deformations were measured through spring-loaded linear variable differential transformers (LVDTs). The tests were conducted within an environmentally controlled chamber that was set to a constant temperature of 77°F throughout the testing sequence. Figure 3 shows a picture of one specimen testing setup.

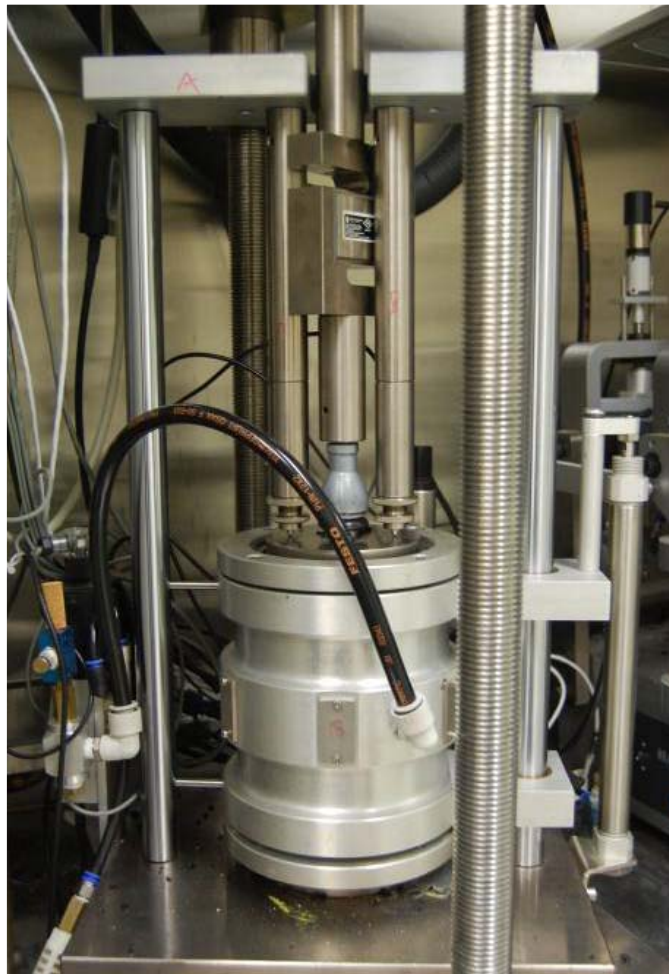
Figure 3. Test setup for confined creep tests.

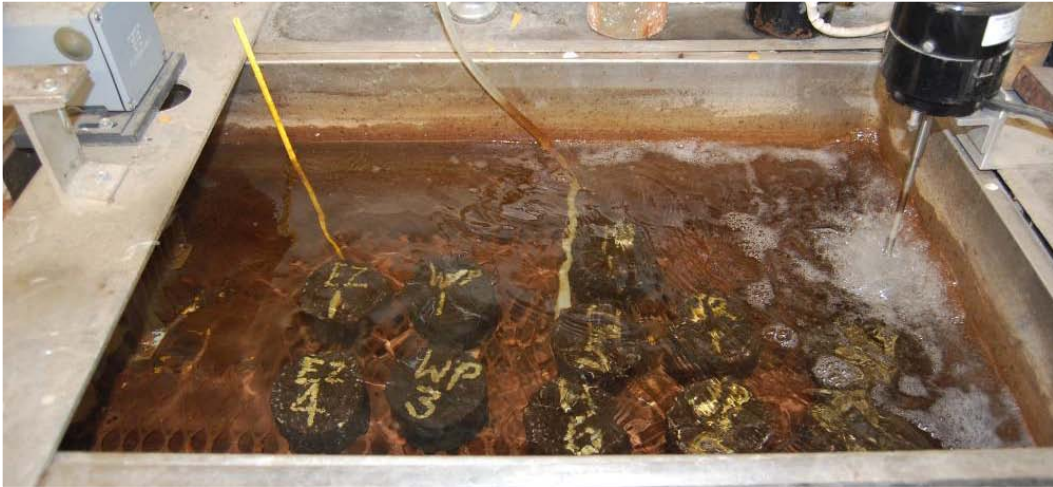
Figure 4. Water bath used to condition the samples for the retained tensile strength test.

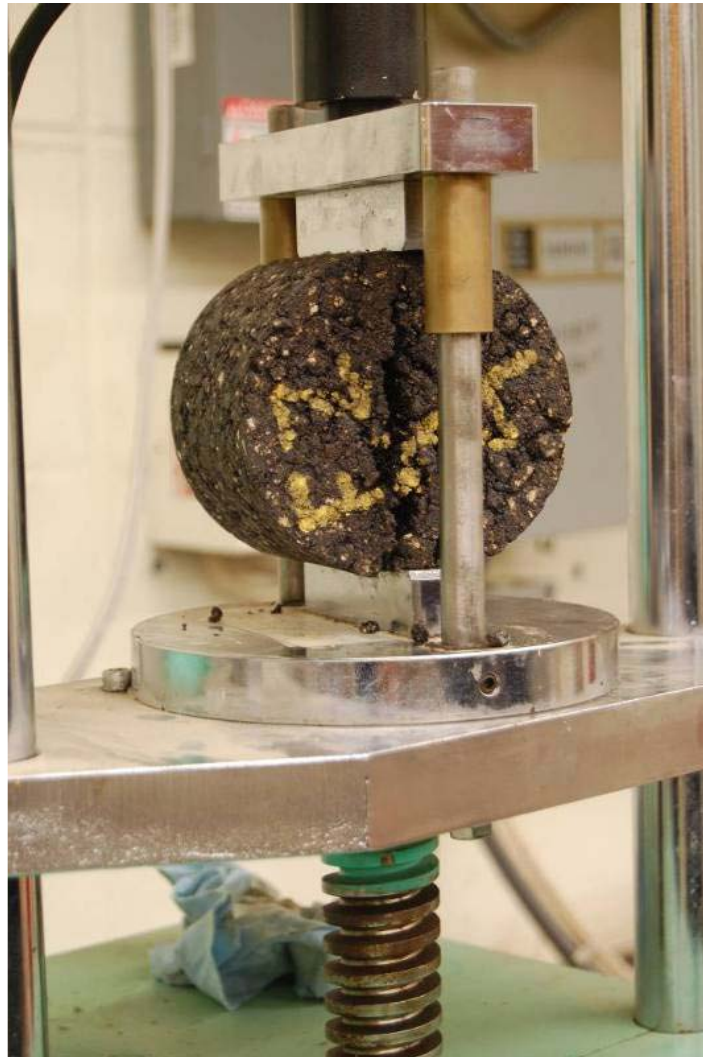
Figure 5: Tensile splitting test.

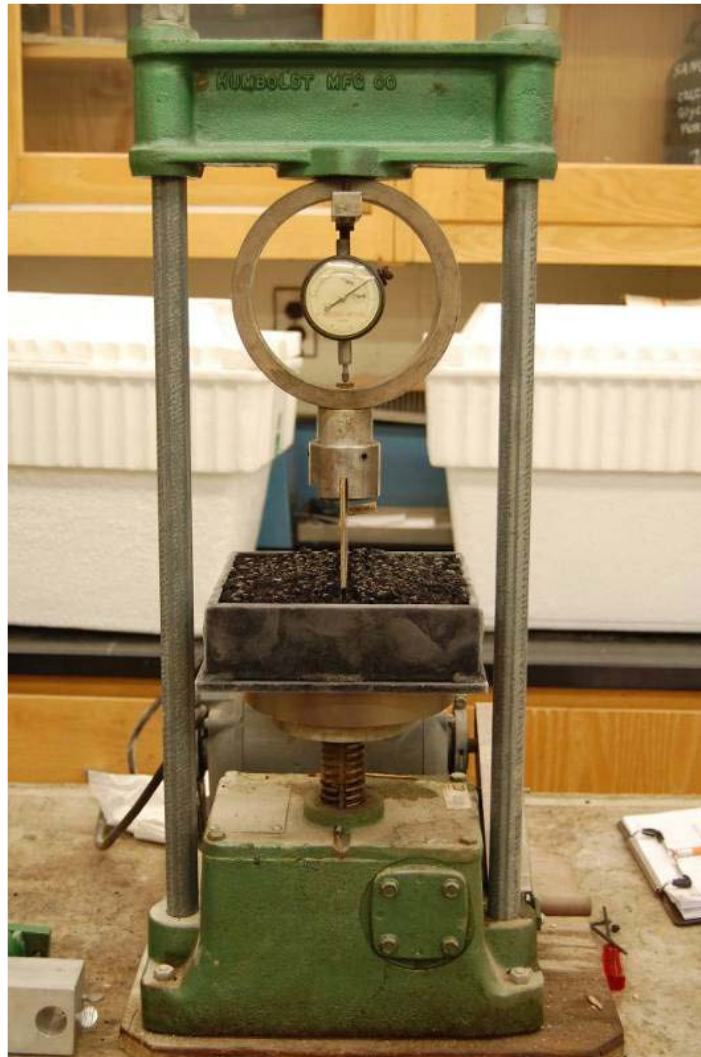
Figure 6. Workability test apparatus.

The ASTM D6704 defines workability as the average maximum resistance to penetration by a designed penetrometer into a compacted asphalt cold mix that is confined in a designated box. Three specimens per product were evaluated. The materials were compacted in the box with two blows of a flat tamping foot compaction hammer and the compacted samples were placed in a freezer at 14°F for 24 hr. The materials were then tested to measure the resistance to penetration using the test apparatus shown in Figure 6.

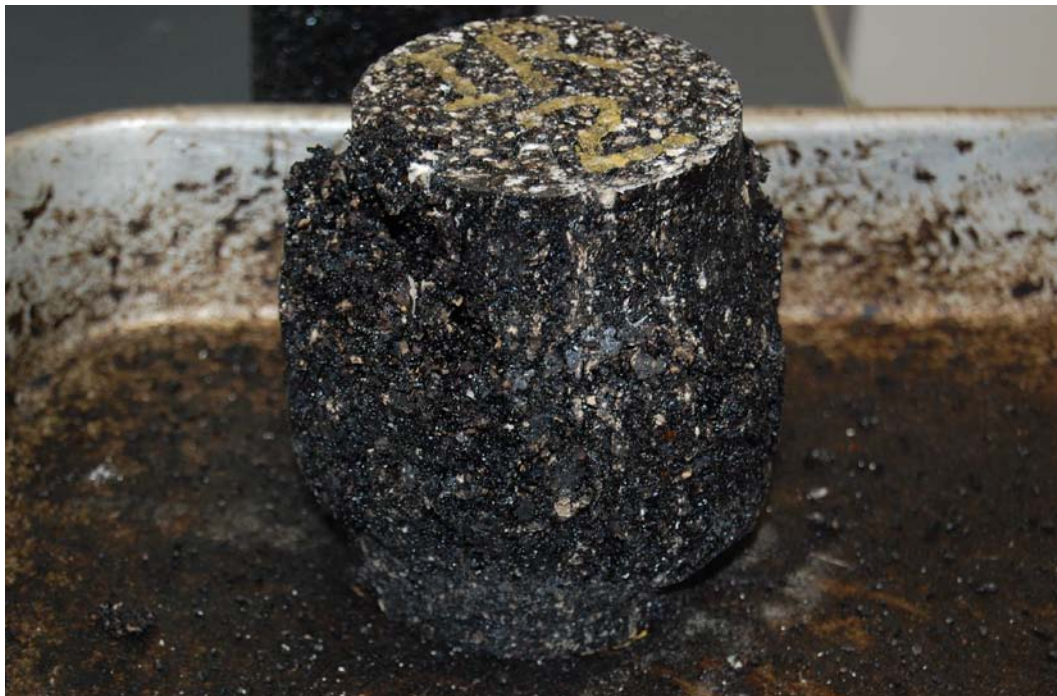
Figure 7. IRR sample after static creep test.

Figure 7 shows the shear deformation of an IRR specimen after the static creep test was completed. Once each test was terminated, the software presented a value for FT in the screen, and created an Excel data sheet with the tests results including deformation, microstrain, and creep modulus. These results are summarized in Tables 5–8 for the four top-performing products, and complete test data are given in Appendix A.

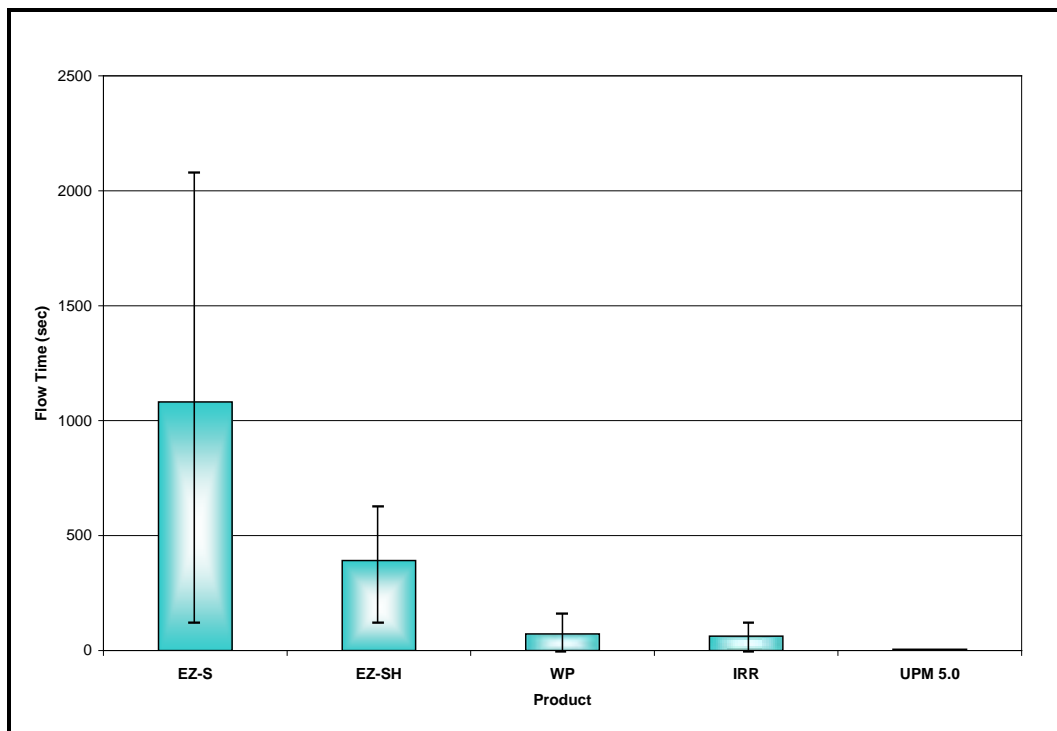
Figure 8. FT per material.

It can be observed that EZ-Street showed a very high FT value compared with the other products. This could indicate that this product has the potential to resist permanent deformation better than the others. However, a large variability was observed in the results of the EZ-Street samples. Two samples showed high FT values while the other two showed low values. The high values could have been considered outliers since the low values were within the range of FT for the rest of the materials. However, there was no observation that would justify classifying these values as outliers. Furthermore, EZ-Street was the material with the highest creep modulus, which indicates that, compared with the other materials, EZ-Street has a lower susceptibility to permanent deformation.

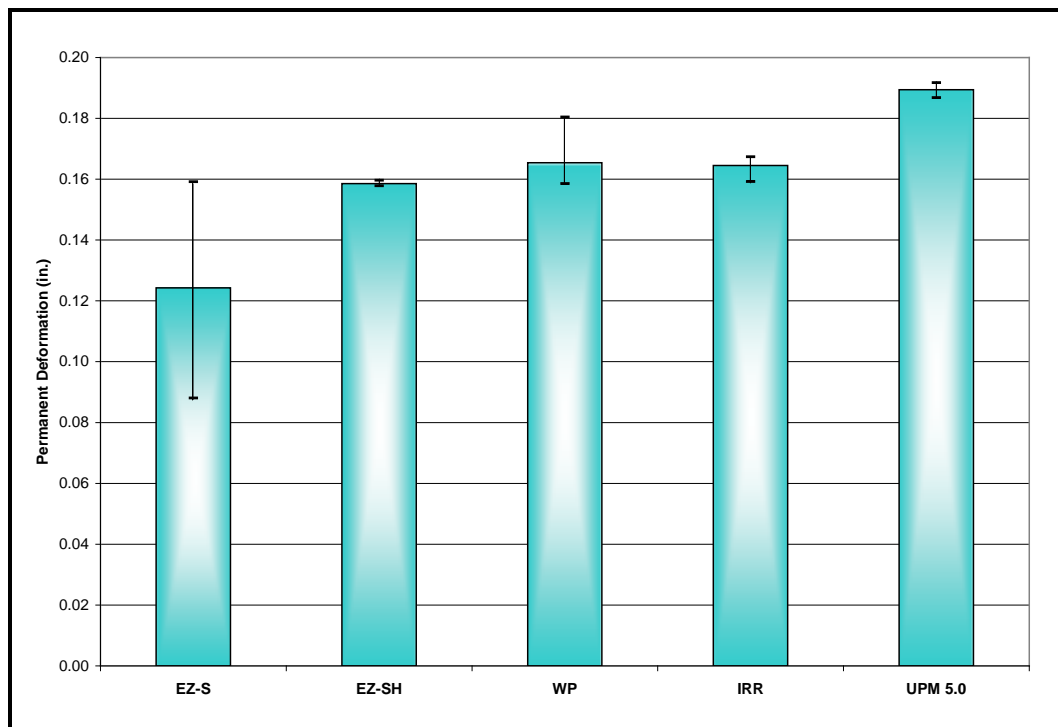
Figure 9. Permanent deformation under static creep loading for each material.

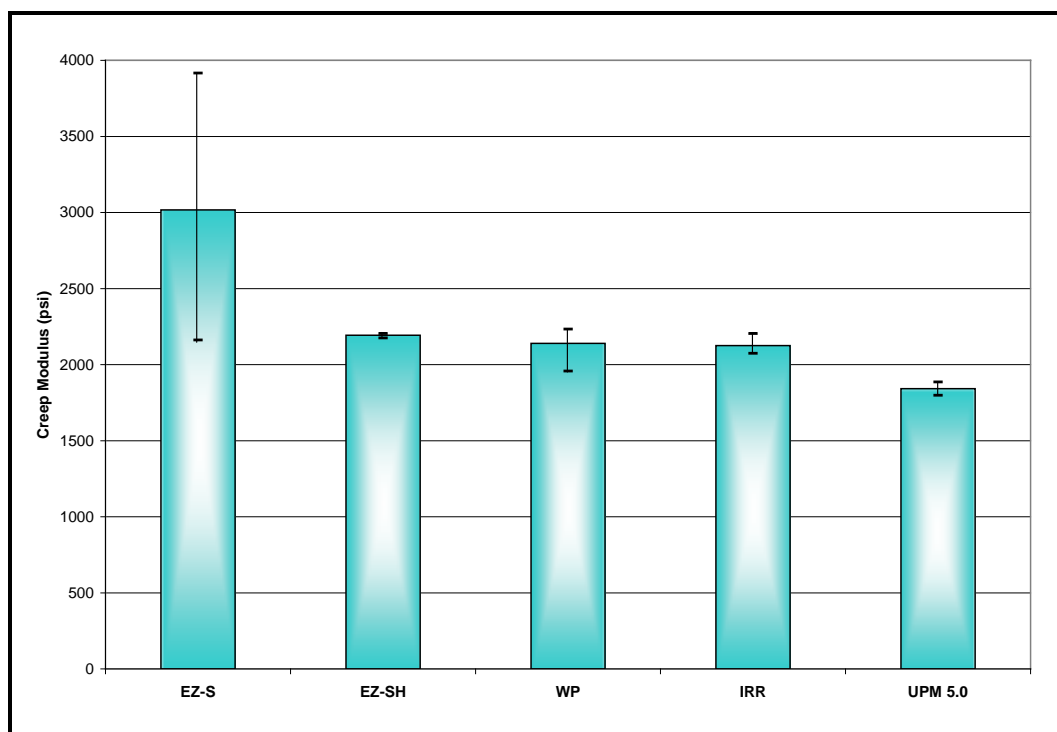
Figure 10. Creep modulus from static creep test for each material.

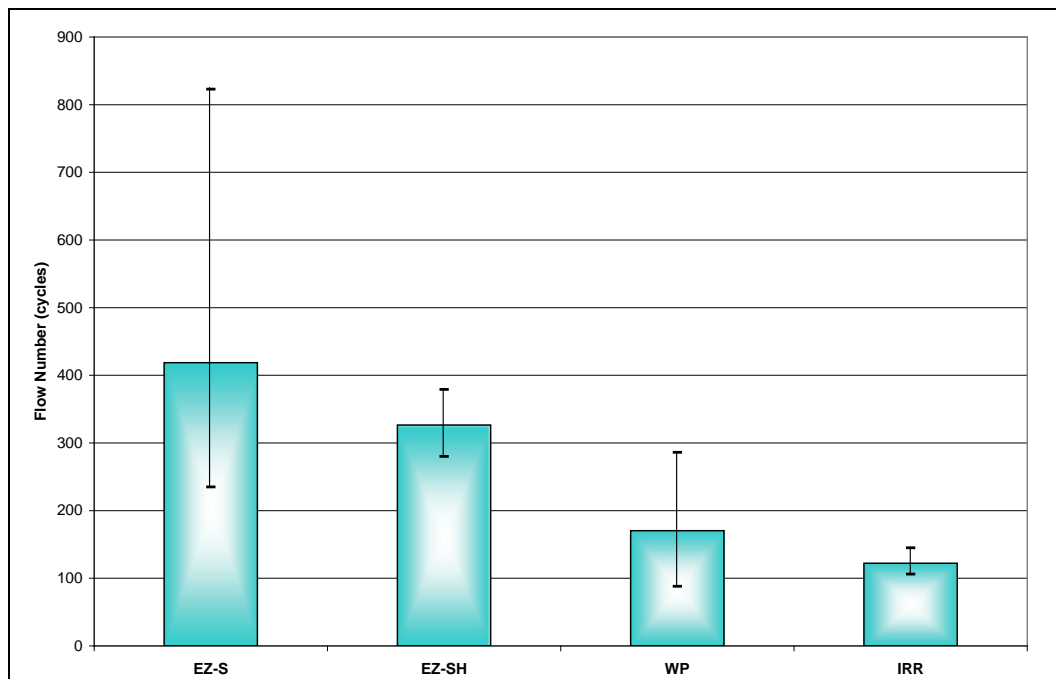
Figure 11. Flow number per material.

The FN values were consistent with the results obtained from the static creep test, in that EZ-Street proved to be the material with highest FN. However, this did not mean that this material resisted permanent deformation under repeated loading better than the others. EZ-Street actually had a higher permanent deformation and lower resilient modulus

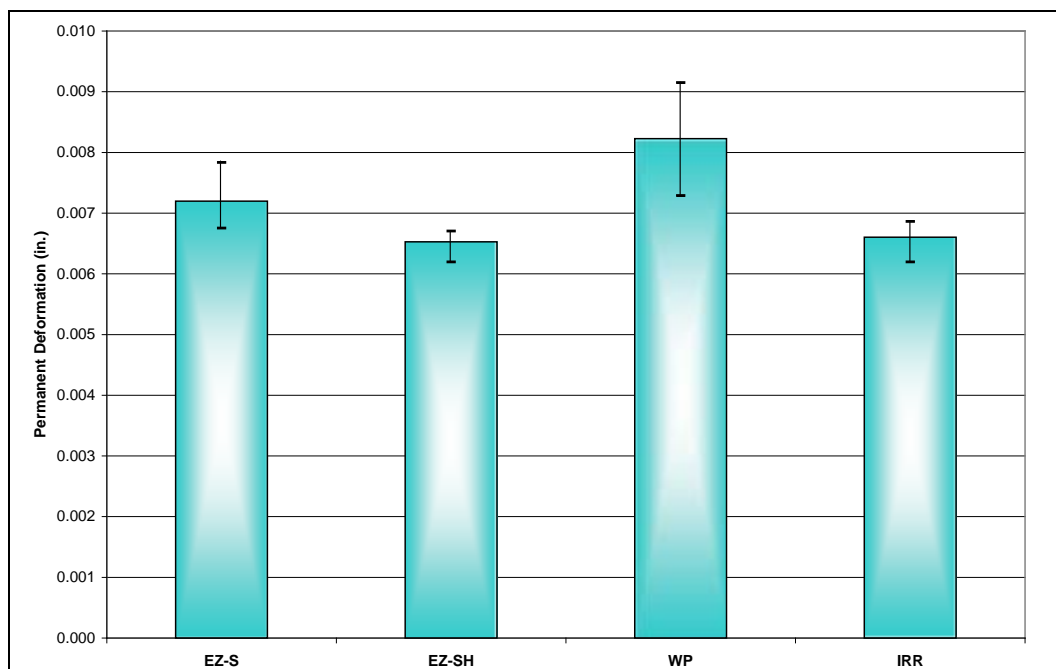
Figure 12. Permanent deformation under dynamic creep loading for each material.

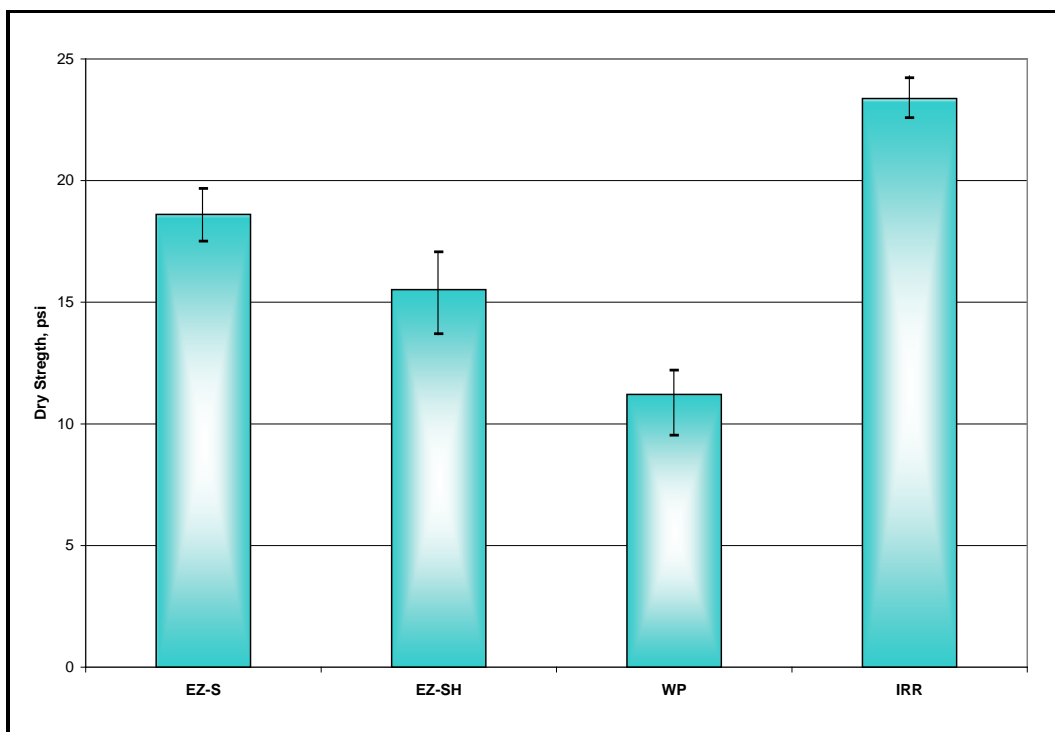
Figure 14. Dry tensile strength of the four top-performing products.

From Figure 14, it can be observed that the product with the highest tensile strength under dry conditions was Instant Road Repair. From Figure 15, Instant Road Repair was also the product with the highest wet tensile strength. However, when comparing the tensile strength ratio (TSR) of all the materials (Figure 16), EZ-Street Hybrid was the one with the highest ratio, i.e. the effect of moisture on this material's tensile strength is less than in the others. Wespro samples broke apart as soon as they were taken out the water bath. Therefore, the wet tensile strength test could not be run for this material. From this, it was concluded that Wespro is not suitable for repairing potholes filled with water, and the product is most likely to have durability problems.

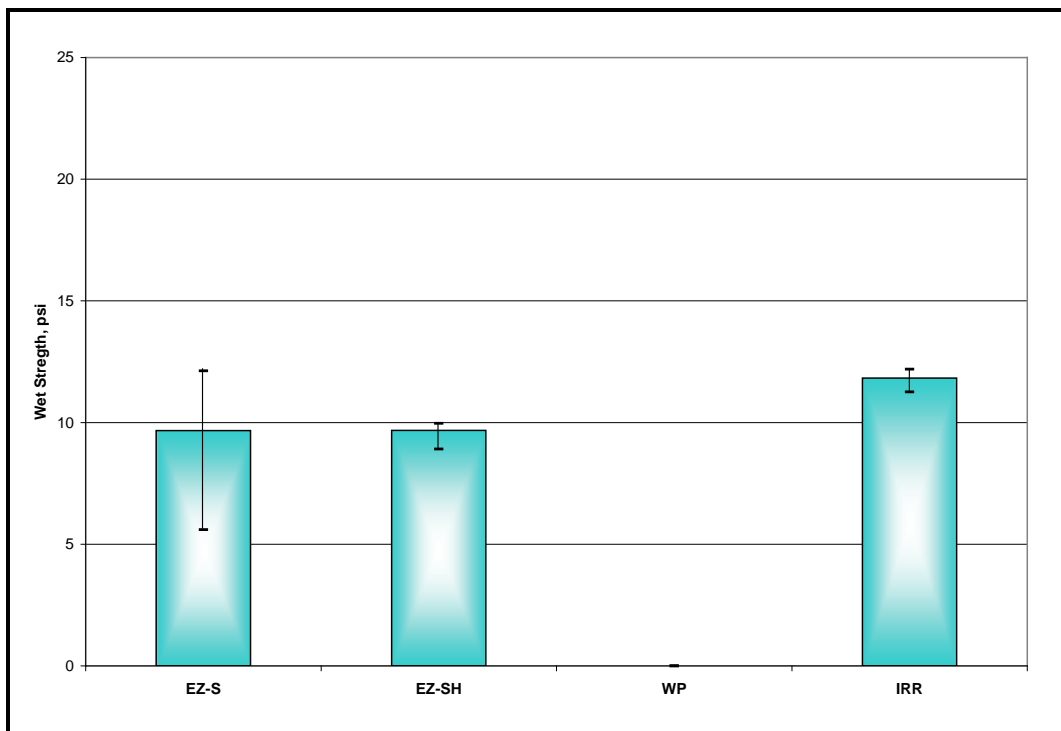
Figure 15. Wet tensile strength of the four top-performing products.

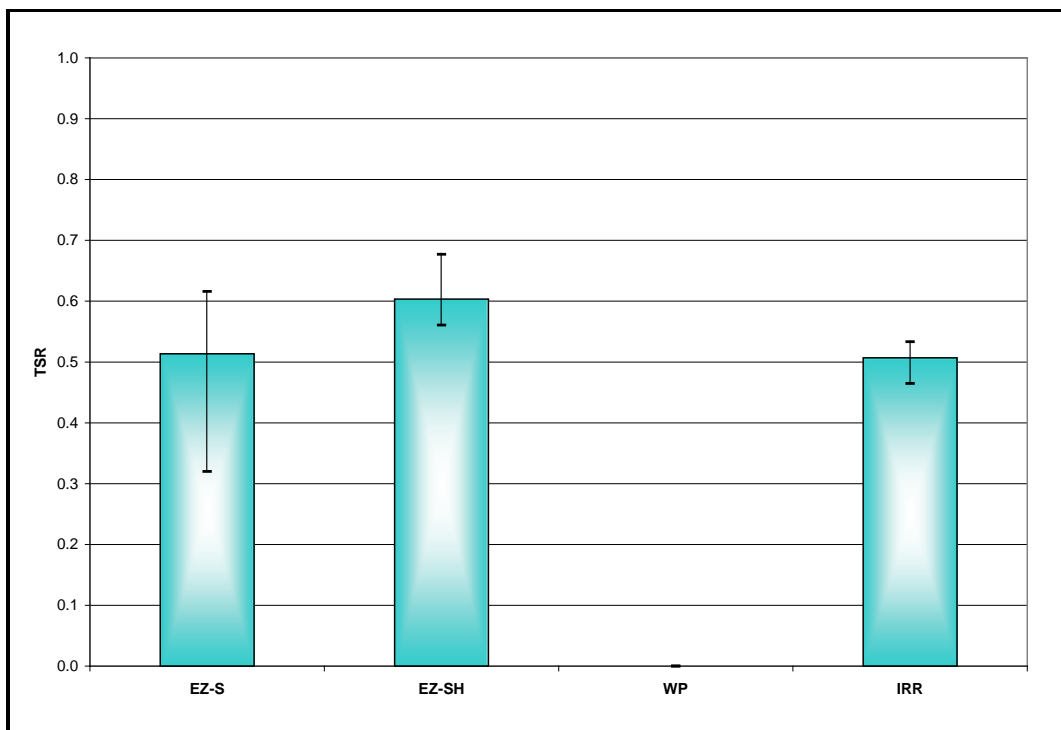
Figure 16. TSR comparison between the four top-performing products.

The four top-performing cold patch products were tested for moisture damage. Two sets of specimens were exposed to different temperature and moisture conditions to evaluate the effect on the tensile strength of the materials and the bonding between the aggregate and the binder. The complete results are listed in Appendix A and summarized in Figures 14–16.

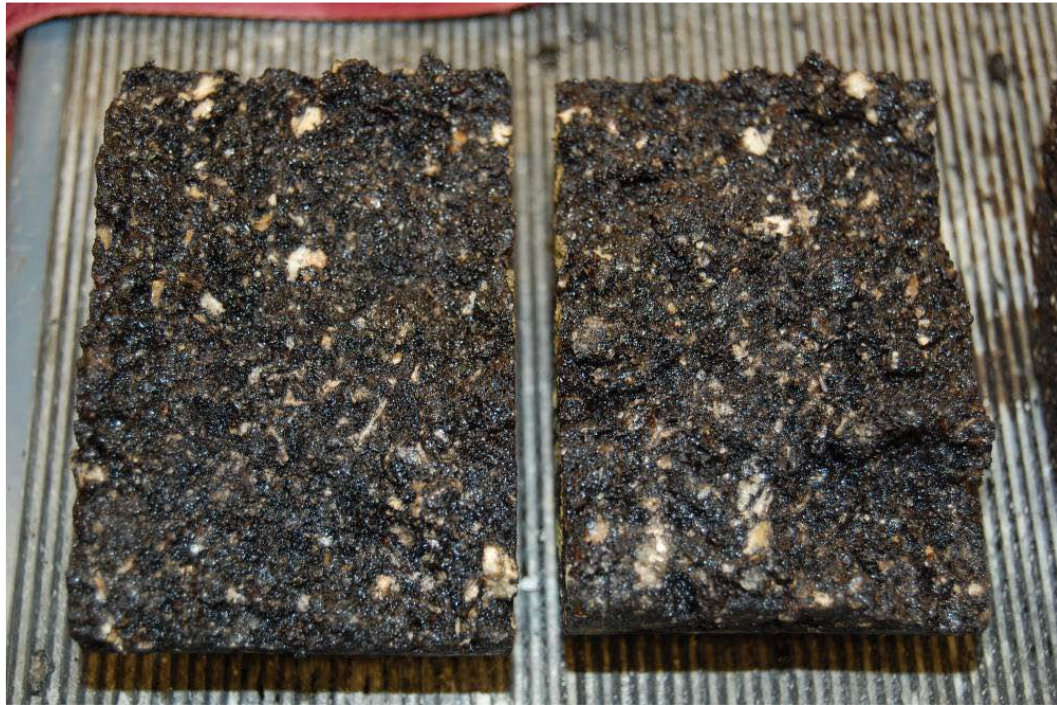
Figure 17. Broken aggregate on an EZ-Street sample.

Specimens were loaded until they fractured. Then, the samples were split to visually estimate the degree of moisture damage. All the surfaces were inspected for evidence of cracked or broken aggregate. Figure 17 shows an EZ-Street specimen split for visual inspection. Most of the specimens examined exhibited broken aggregates, and stripping of the binder from the aggregates was also observed.

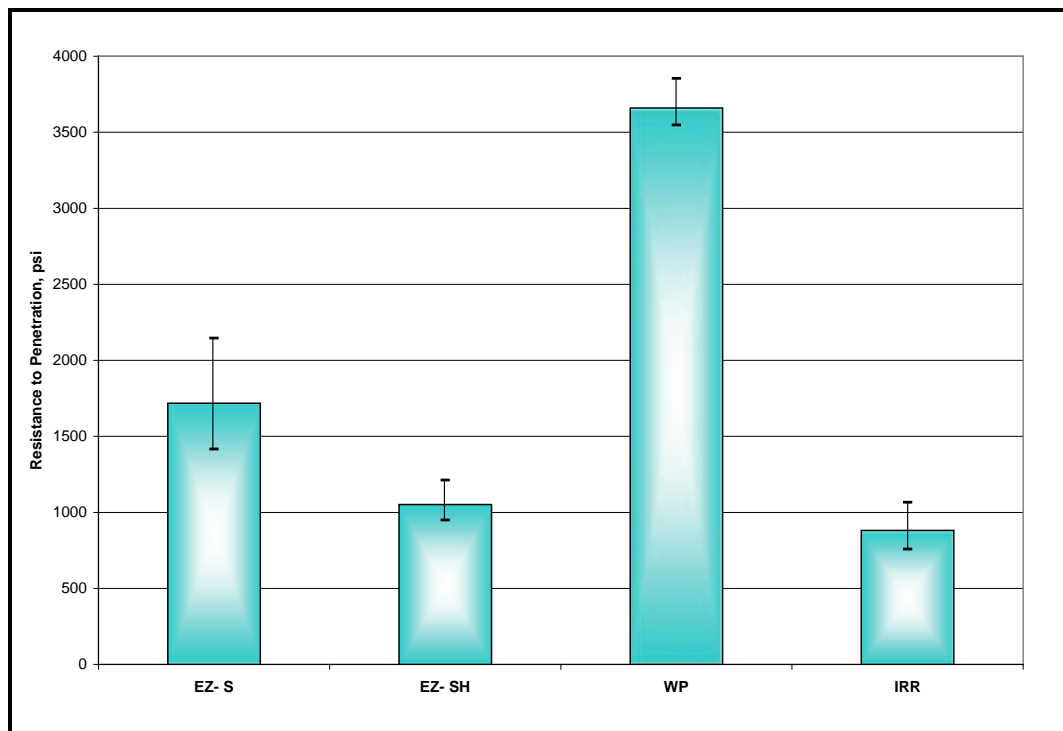
Figure 18. Workability test results.

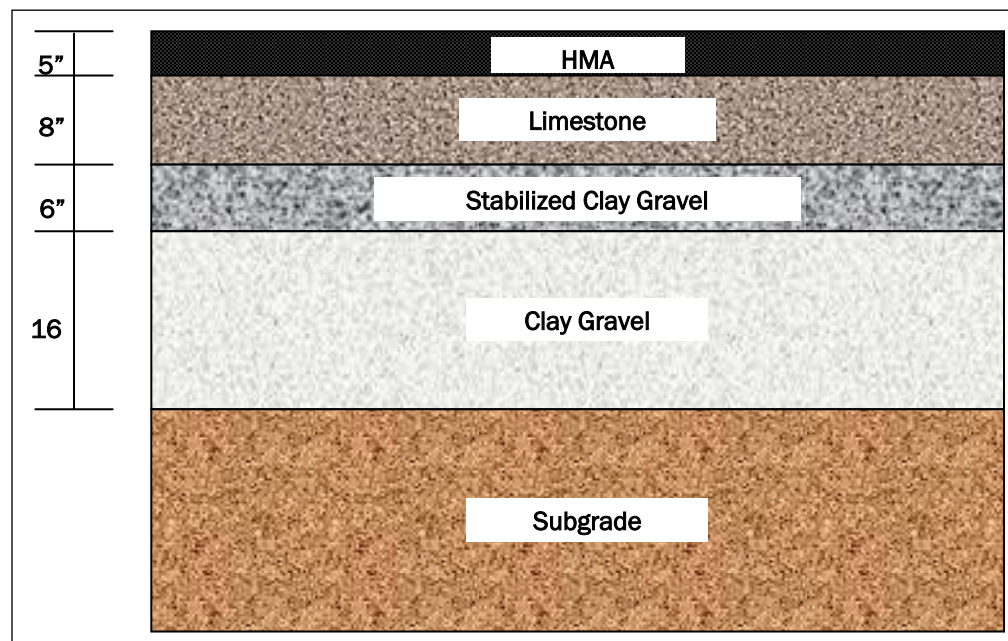
Figure 19. Pavement structure in the test section.

The field test was conducted on a HMA pavement section located at the ERDC. The test section was originally designed to withstand 50,000 passes of a C-17 aircraft. The pavement structure consisted of 5 in. of HMA over 8 in. of limestone, 6 in. of stabilized clay gravel, 16 in. of clay gravel and, finally, the subgrade (Figure 19). The area selected for the test was located at the southeast corner of the HMA pavement section.

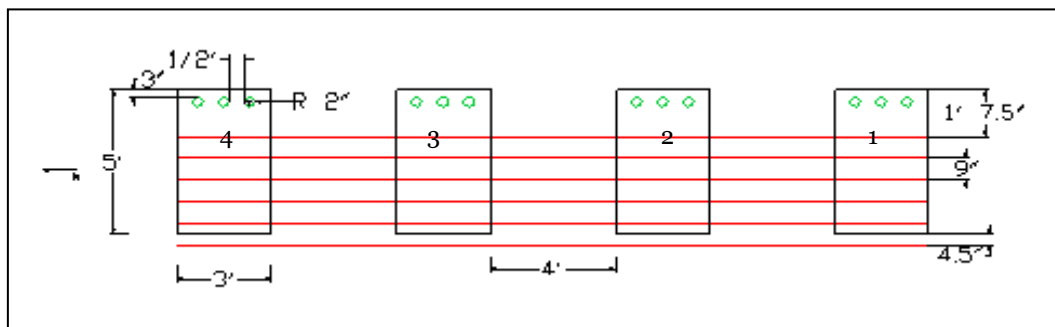
Figure 20. Test section details.

The test area consisted of four repairs, each 5 ft long by 3 ft wide by 5 in. deep (Figure 20). The repairs were prepared by cutting through the HMA surface with a dry-cut saw and clearing the debris. To determine the amount of material required to fill each hole, the total volume of each hole was calculated by measuring the average depth and multiplying it by the known repair area. Manufacturers' usage guides were consulted to calculate the amount of material required to fill each hole. Table 16 presents these amounts for each material. In general, the required amount of cold patch asphalt was three buckets or three bags per cubic foot of repair for all four products.

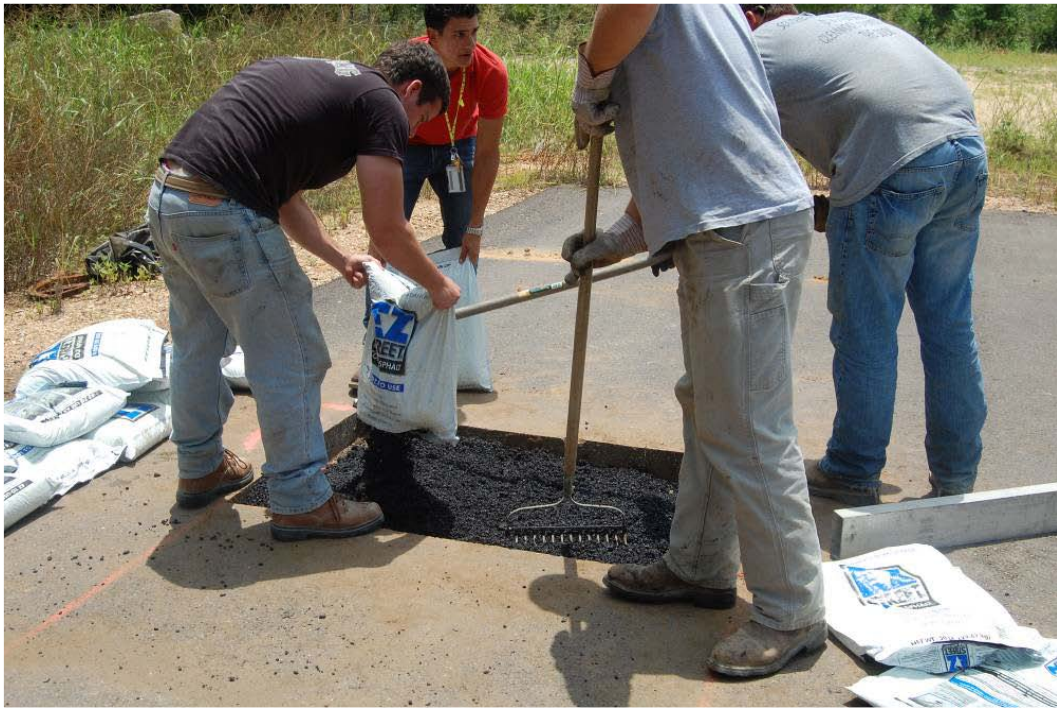
Figure 21. Material placement.

Manufacturer guidelines were followed in placing the products, to guarantee the correct repair technique. Before placing the materials, the holes were cleared of any debris or water, as recommended by the manufacturer. Material was placed straight from the manufacturer's packaging into the holes (Figure 21) and then was compacted in two 2-in.-deep layers. A rake was used to uniformly distribute the material (Figure 22).

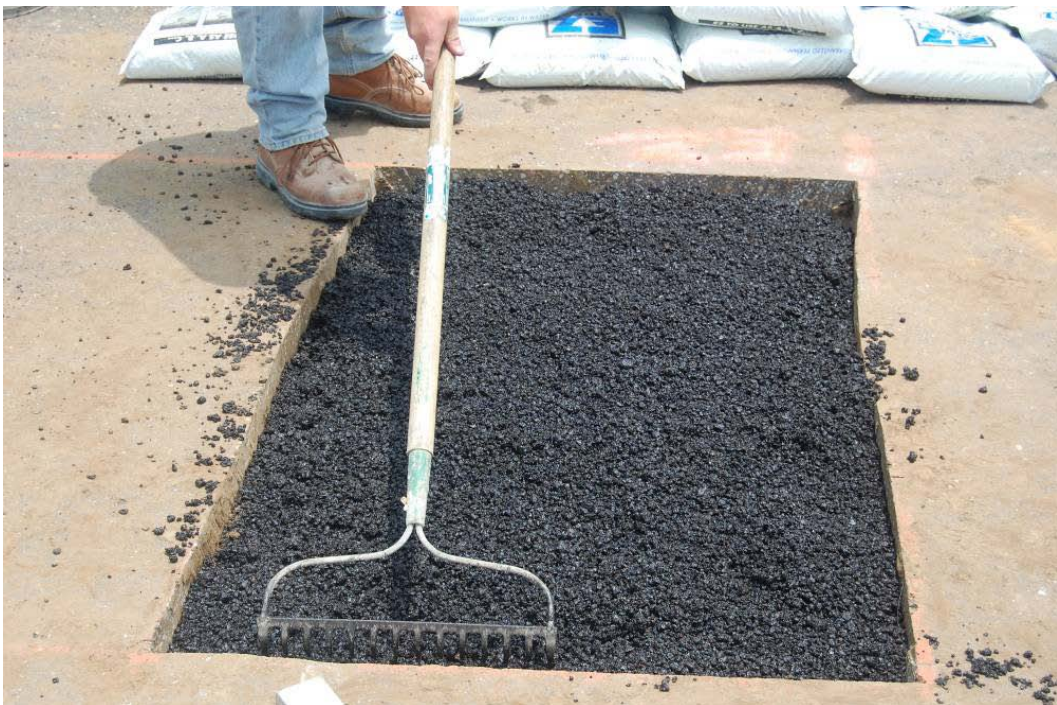
Figure 22. Spreading of the material.

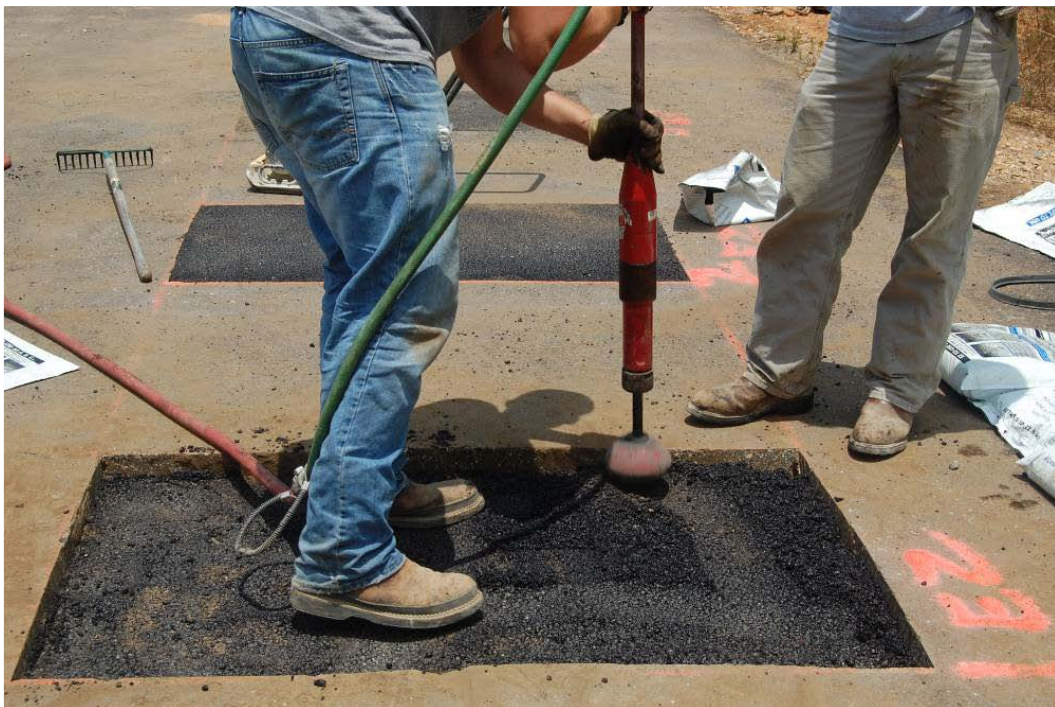
Figure 23. Pneumatic tamping compactor with a 5-in. circular head.

For each repair, the first lift of material was compacted initially with several coverages of the pneumatic tamping compactor with a 5-in. circular head (Figure 23). The remaining compaction of the first lift was accomplished with about 10 to 12 coverages with a vibratory plate compactor (Figure 24). The second lift was compacted by using only the vibratory plate compactor. Material placement and compaction was performed one day, and the products were trafficked the next day.

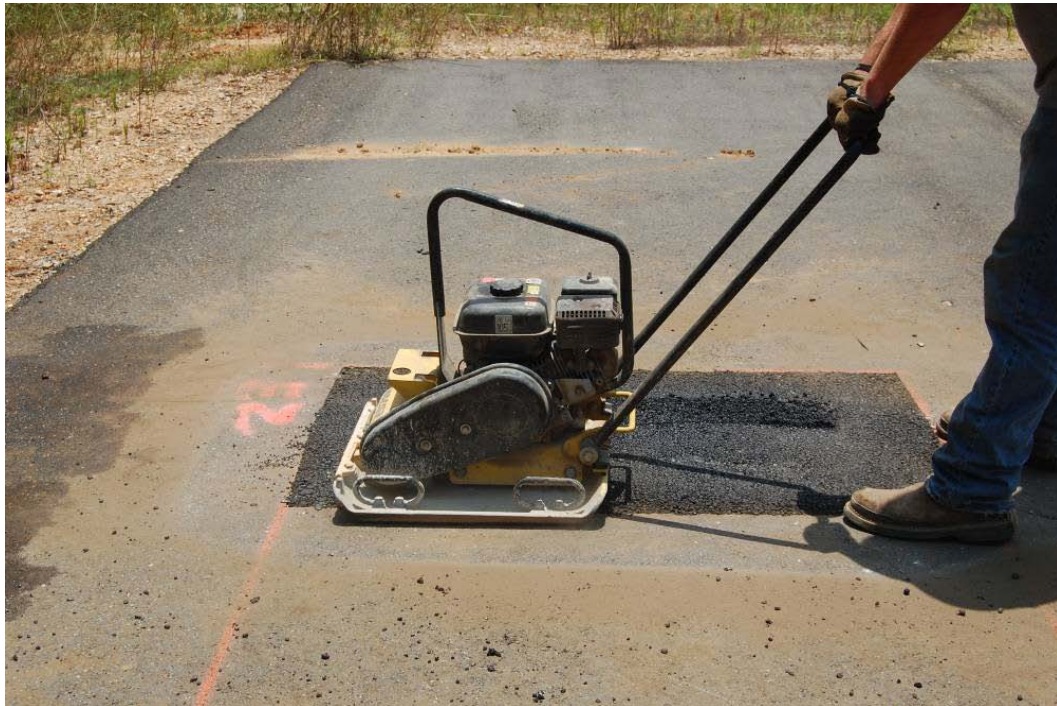
Figure 24. Vibratory plate compactor.

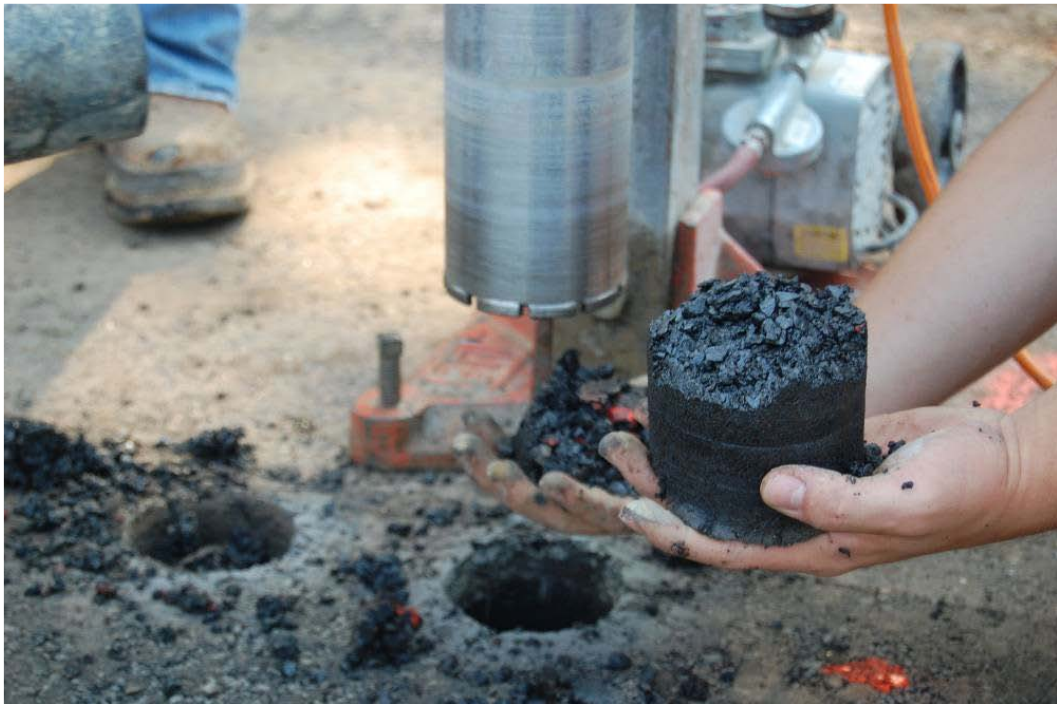
Figure 25. Core sample falling apart due to high air voids in the mix.

The testing plan called for taking at least three cores from each repair to determine more accurately the initial air voids content and compaction density. However, it was not possible to obtain uniform core samples (as shown in Figure 25). This could have been attributed to a cold mix issue such as low laboratory air voids or a low field density issue. No measurements of the initial air voids were available, and initial compaction could not be determined more accurately. However, density measurements were taken with a nuclear gauge to have an estimate of the in situ density of the materials after compaction (Figure 26). These measurements are presented in Table 17.

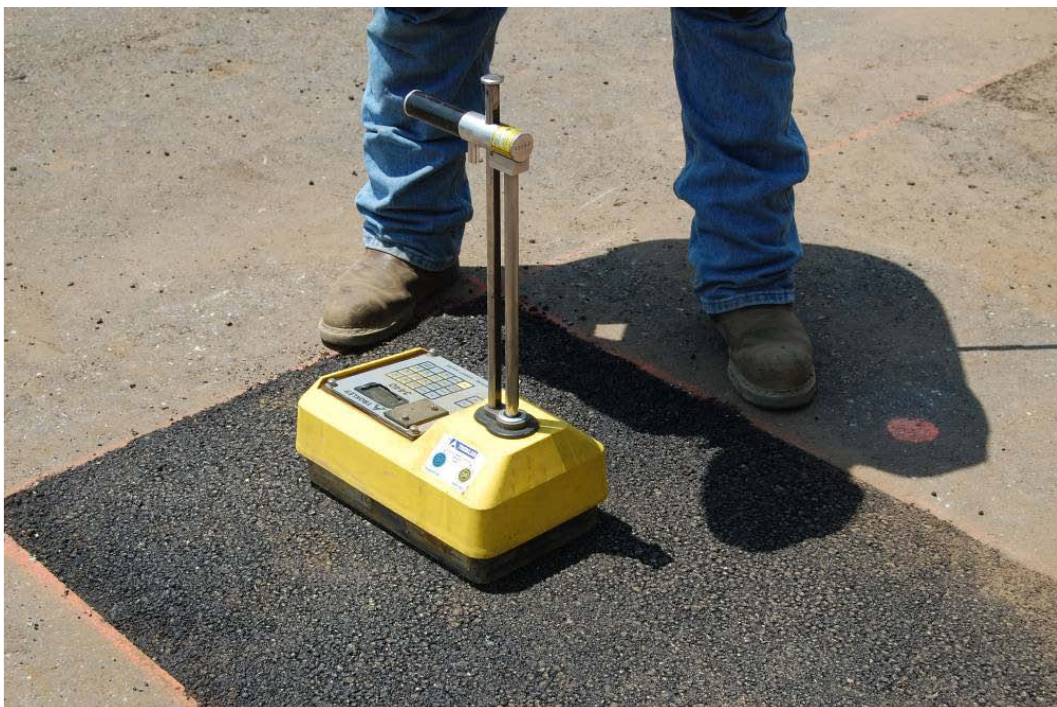
Figure 26. Nuclear gauge.

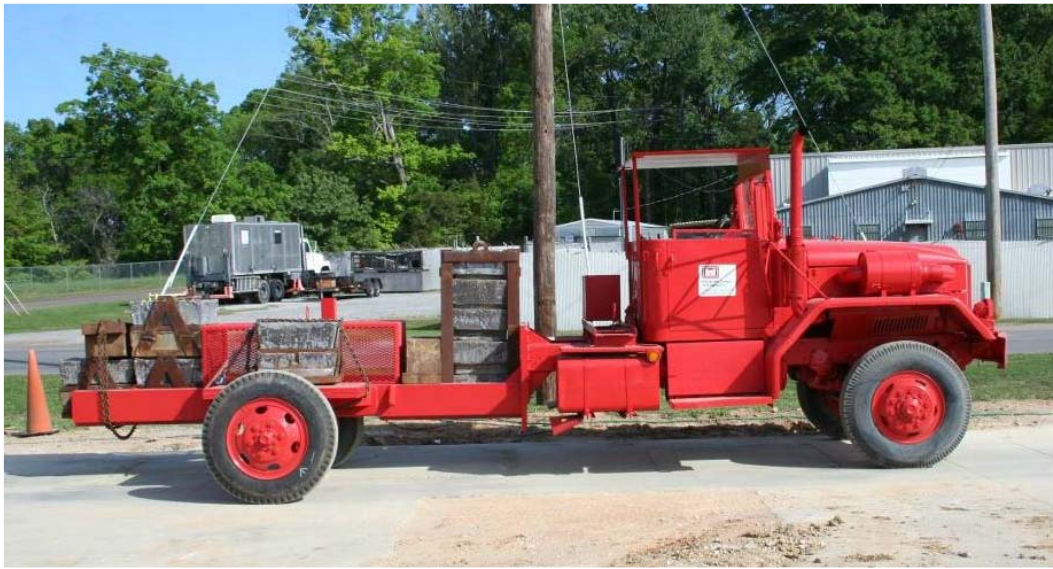
Figure 27. F-15E load cart.

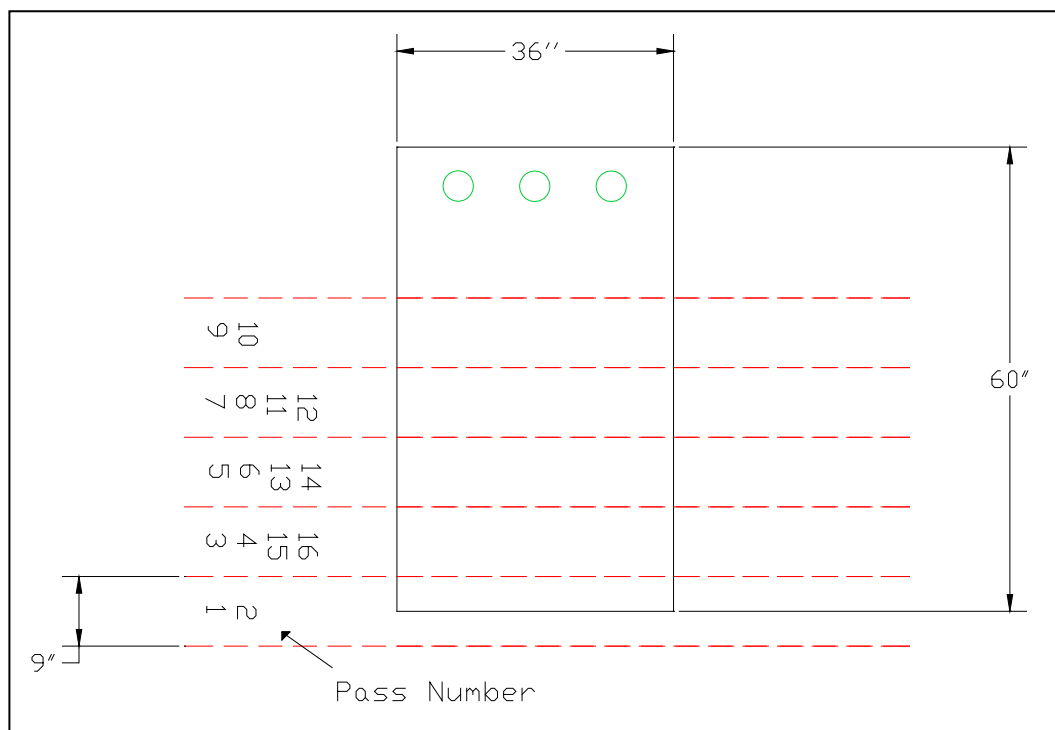
Figure 28. Traffic pattern.

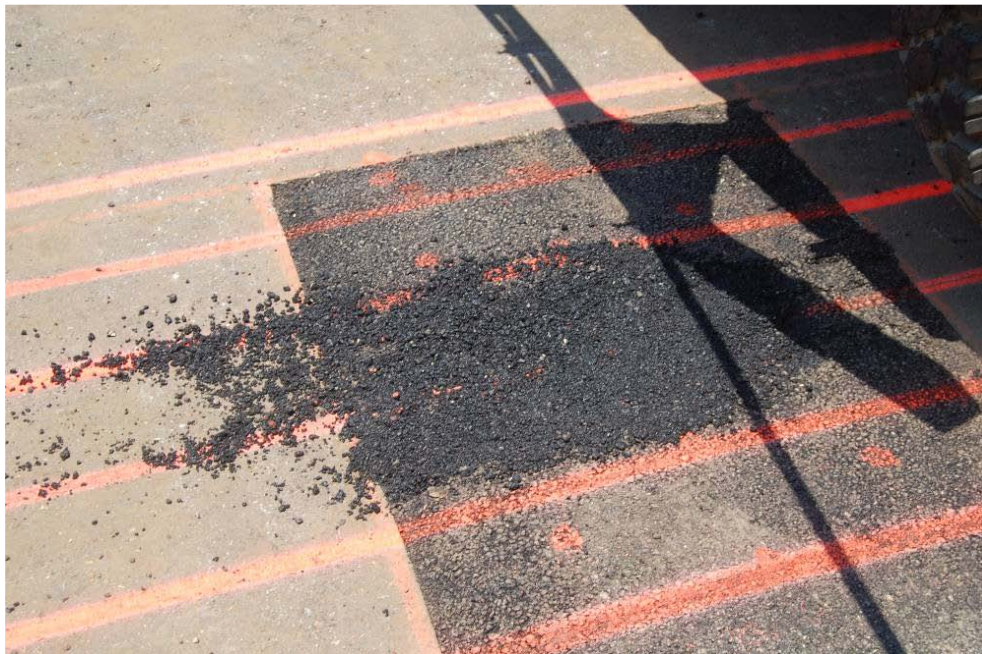
Figure 29. Damage in the EZ-Street Hybrid product.

a turn. While the wheel was turning and moving at the same time, the material in the repair was dragged by the wheel, causing some of the material to loosen, as shown in (Figure 29). This surface failure gave an indication of a mode of failure that could be expected from this material when subjected to traffic. Also, this failure could have been a product of low compaction or inadequate cohesion of the mix. Table 18 presents the amount of compaction obtained for each repair determined as a percentage of bulk density of laboratory compacted samples. Compaction for EZ-Street Hybrid was low and, in this case, could have been caused by poor compaction procedures or problems with the mix, such as low amount of fines or poor bonding between the aggregates and the asphalt binder. Low compaction was also observed for EZ-Street with 92% of laboratory density.
